Using Building Data Analytics to Bridge Gap Between Teams

Project at a Glance

Location: Michigan Facility: Hospital Facility 7 Minute Read

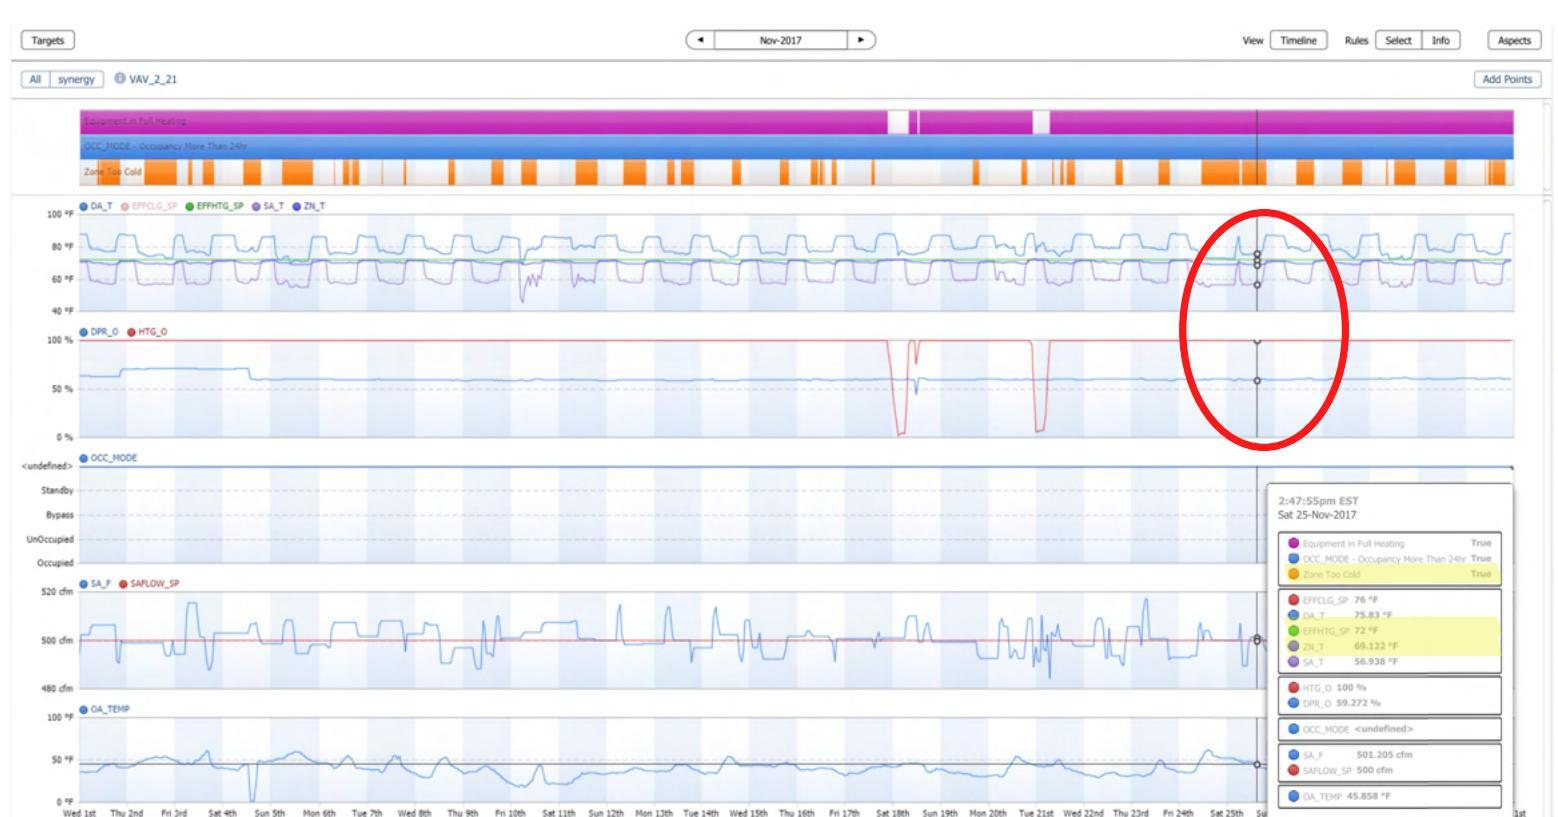
Below: Example of VAV heating at 100% but zone temperature less than setpoint (insufficient capacity).

From hiring Synergy for implementation to report, the owner was able to experience results within 60 days in the clinic building. Through Data Analytics, it was confirmed that some of the electric resistance coils were in fact undersized for the actual conditions. Synergy suggested replacing equipment that was undersized and recommended modifications be made to the equipment that was not operating at full capacity. Once the coils were changed by the contractors, the space temperatures in the identified
